**SMITTY'S CATFISH POND DAM
MADISON COUNTY, MISSOURI
MO 30613**

**PHASE 1 INSPECTION REPORT
NATIONAL DAM SAFETY INSPECTION**

APRIL 1981

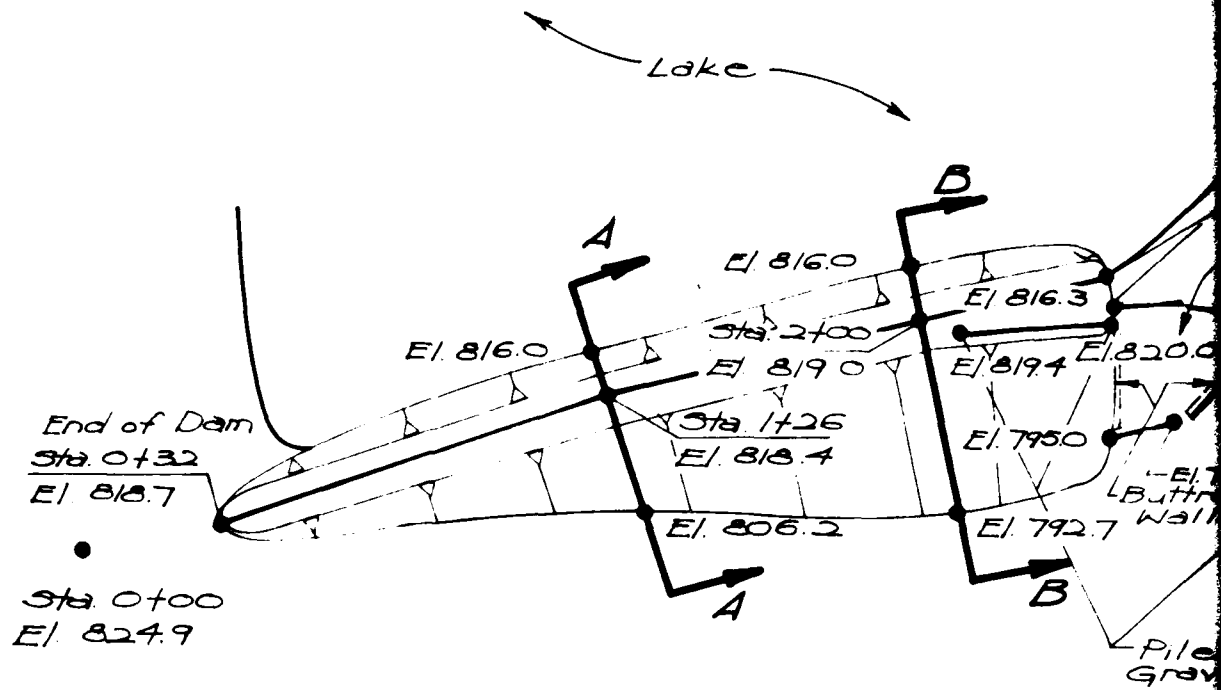
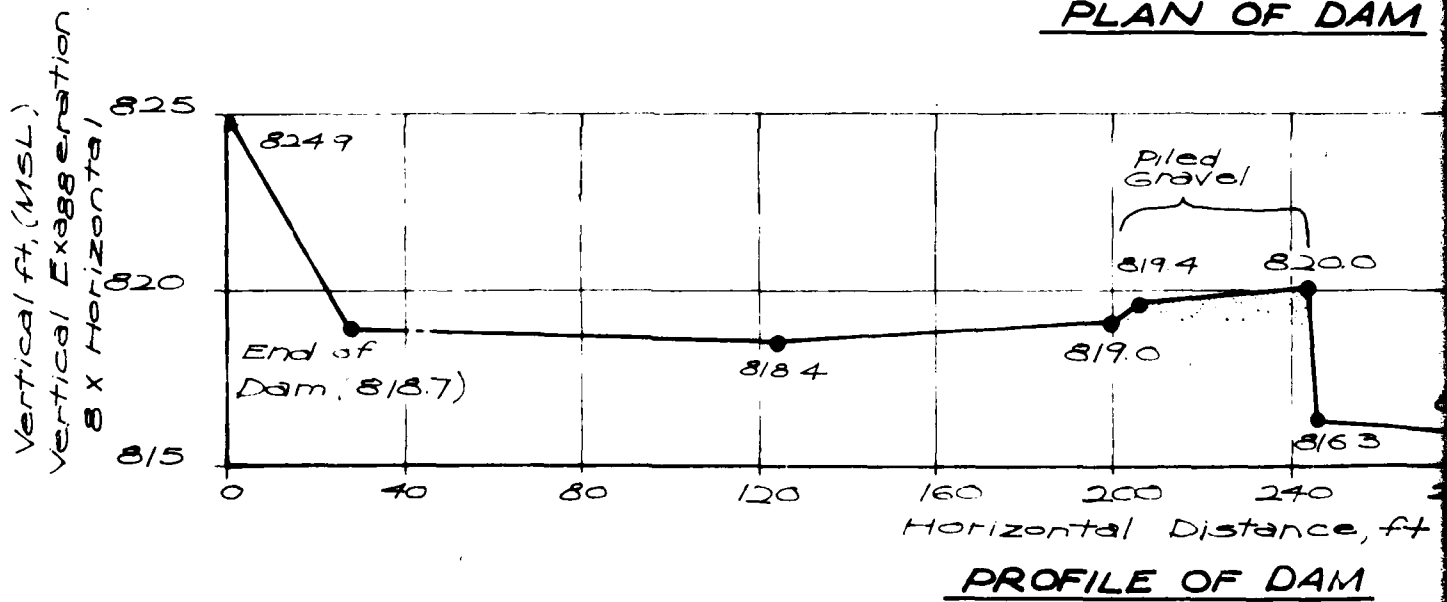
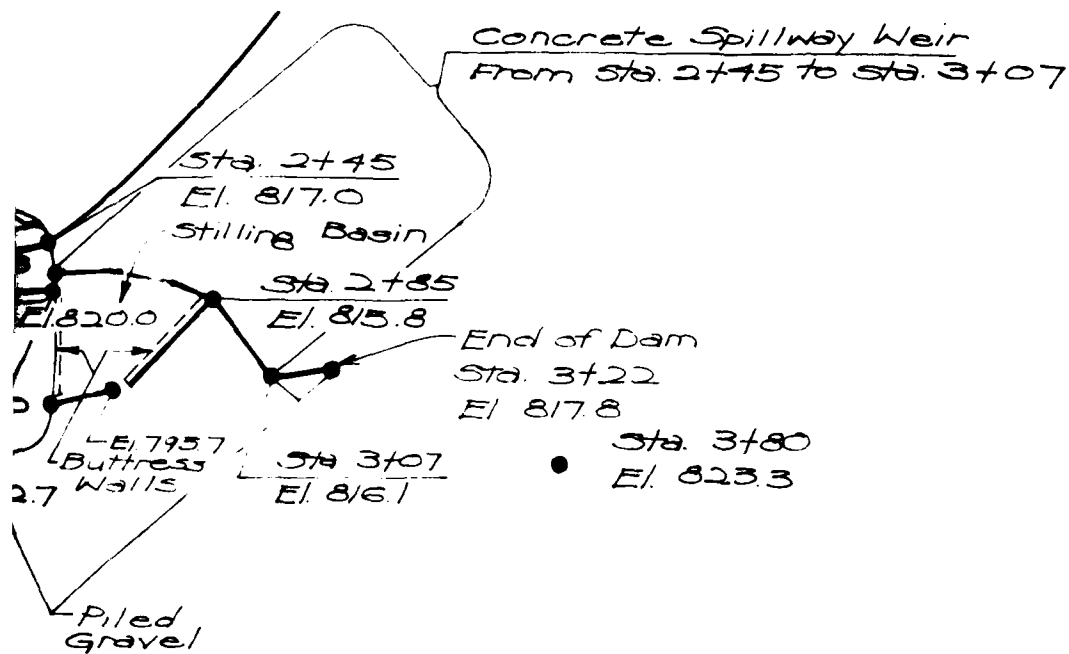
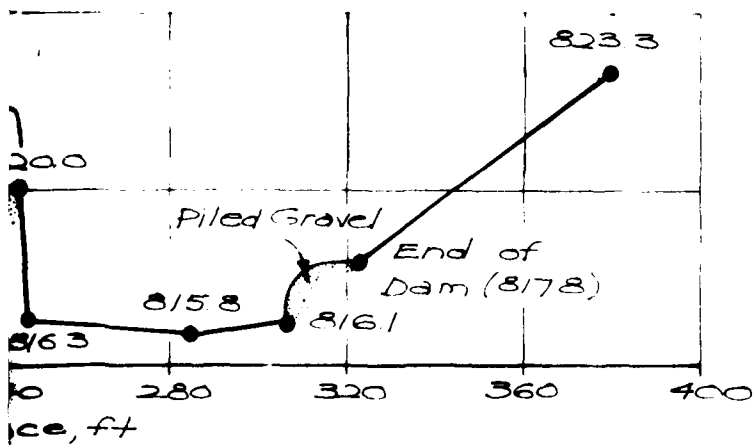
Fig. 3-A

A slump was noted on the downstream slope of the embankment, in the vicinity of Sta 2+00 on Fig. 3A, possibly as a result of the steep slope. The slump was recent, evidenced by a distinct scarp and lobate toe. The volume of the slump was estimated at 2 to 3 yd³.

- d. Overtopping potential. One of the primary considerations in the evaluation of this dam is the assessment of the potential for overtopping and consequent failure by erosion of the embankment. Because the spillway of the dam is concrete, erosion at the spillway due to high velocity discharge is not expected to be a major consideration. The junction of the spillway and left abutment is also concrete covered and consists of outcropping bedrock. This area is also considered not to be subject to significant erosion. The lowest portion of the crest of the dam, near the center of the embankment (Fig. 3A), was considered the minimum top of dam for the overtopping analysis.
